Service Note		
Product	Description:	Service note no.
BM6 MKIII	Cure to RFI problems	SNo-T197

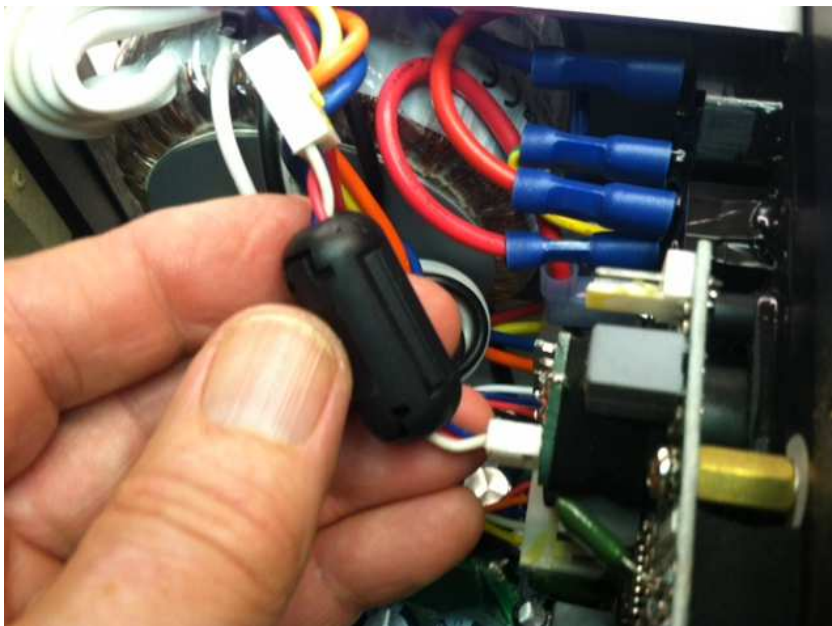
- *Set the wires straight and place a snap-on ferrite over the cable:*

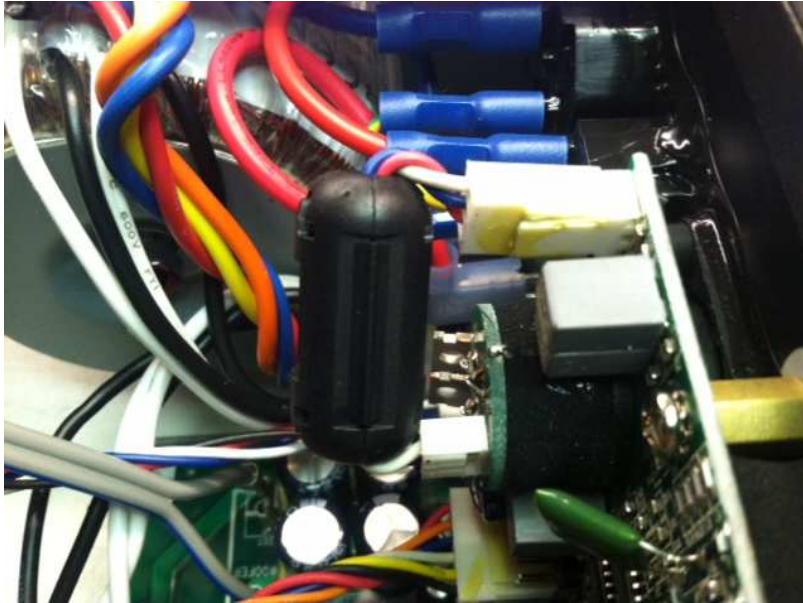
- *Reconnect the connector on the board:*

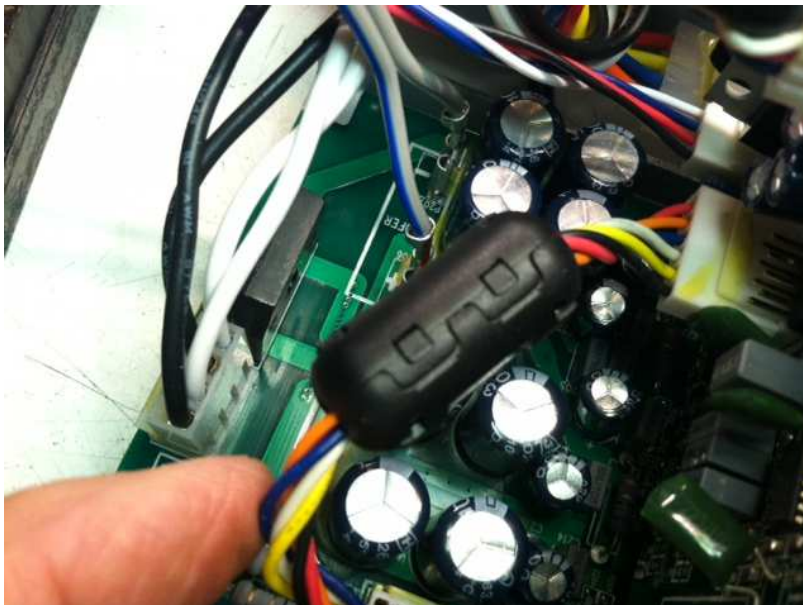
- *Place a second snap-on ferrite on the cable interconnecting the pre-amp board to the output/PSU board:*
