Restriction nr2

About replacing the SP100F, SP130F, SP140F and MIS10006, MIS10007, MIS10008, MIS130

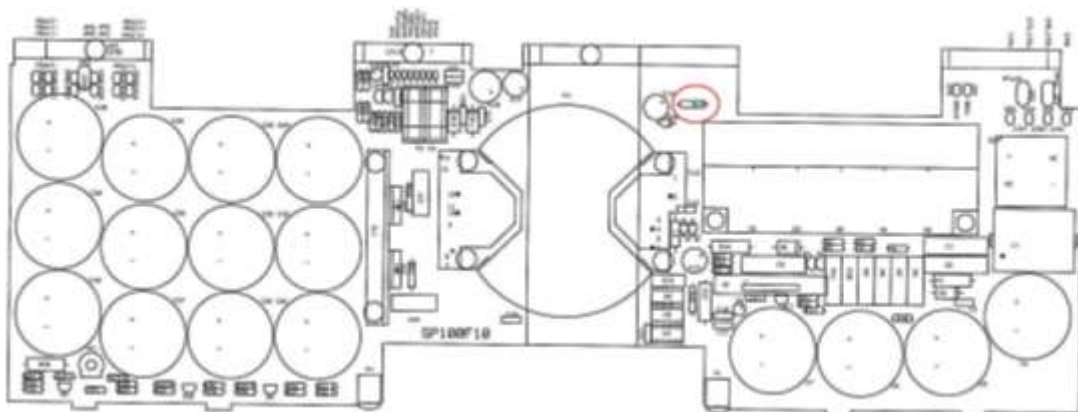
Picture below shows the placement for R19 on SP100F, SP130F and SP140F. The resistor on the SP130 and SP140 may already been disabled by a trace on the back of the board, make sure to check this before you disable any of the two resistors.

When replacing SP100F, SP130F or SP140F or MIS10006, MIS10007, MIS10008, MIS130 in an amplifier you need to make sure that one of the 33Ω resistor is active either R19 on SP100F/SP130F/SP140F or R5 on MIS100/MIS130. If both are active you will have to disable one of them.
