## Restriction nr2

About replacing the SP100F, SP130F, SP140F and MIS10006, MIS10007, MIS10008, MIS130

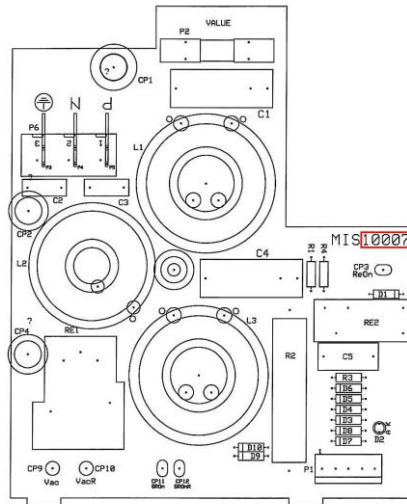
When replacing SP100F, SP130F or SP140F or MIS10006, MIS10007, MIS10008, MIS130 in an amplifier you need to make sure that the 33Ω resistor is NOT active at both R19 on SP100F/SP130F/SP140F and R5 on MIS100/MIS130.

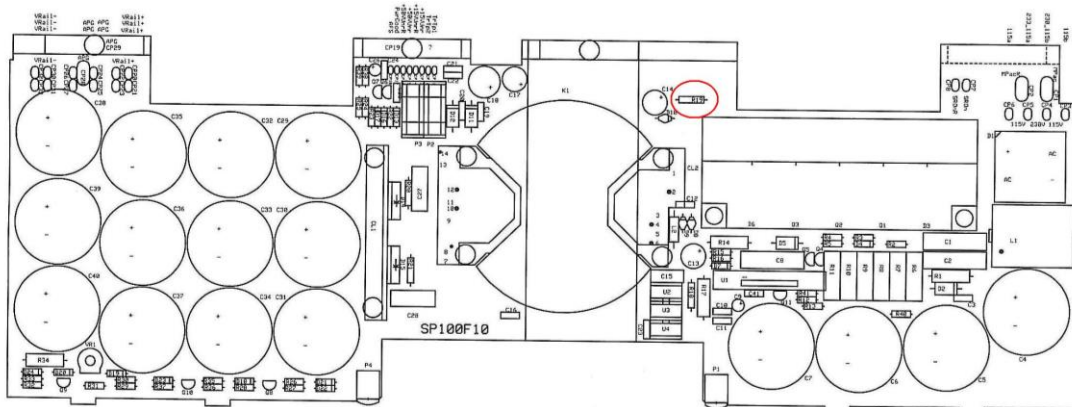
Picture below shows placement for R19 on SP100F, SP130F and SP140F.
