**Reason for note:**

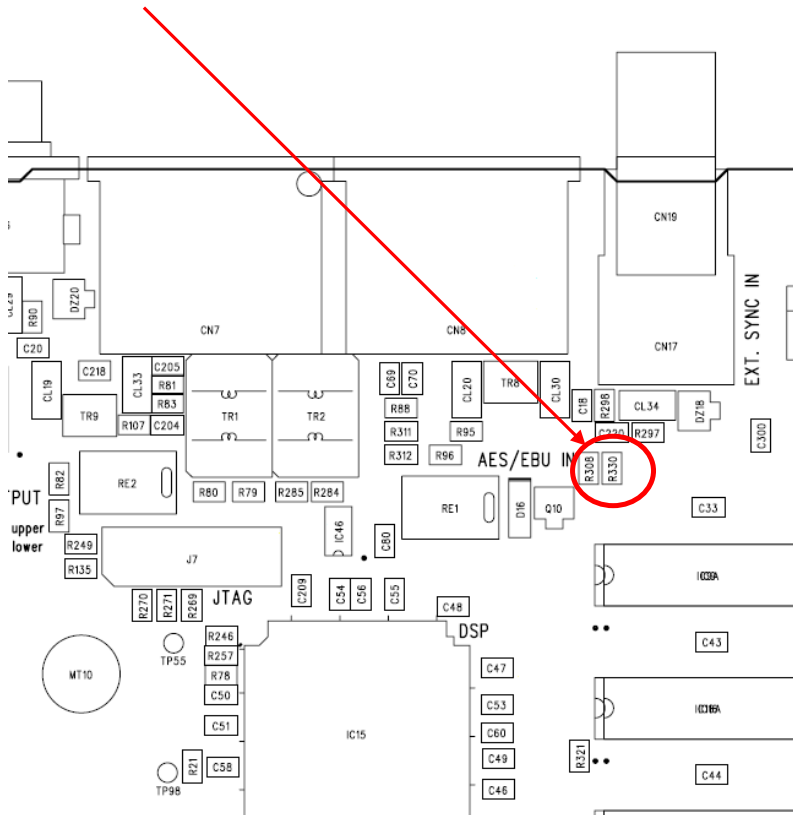
Resistor for base on transistor for bypass relays must be reduced to ensure that the transistor is properly switched on and thereby switch on both digital (AES/EBU) relays properly.

The error shows as missing AES/EBU signal IN and/or OUT.

Change R330 to a 1k1.
