## **Technical Service Bulletin No. 23**

Reference no: Measure for broken NTC in DC/DC on SP200PCF

PLM20000Q

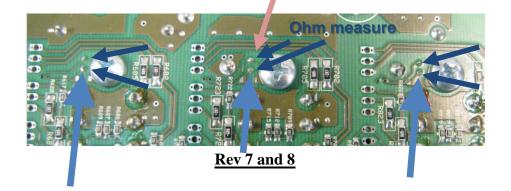
Example OK measurement of NIC702 on a **Rev8** SP200

6. If any of NTC601, NTC702, NTC802 does **not** pass ~18-20kOhm at room temperature, this NTC needs to be exchanged.
