# Technical Service Bulletin no. 29

**Created by: Lab.gruppen AB Service Department**

**Date: 20121124**

## Affected models

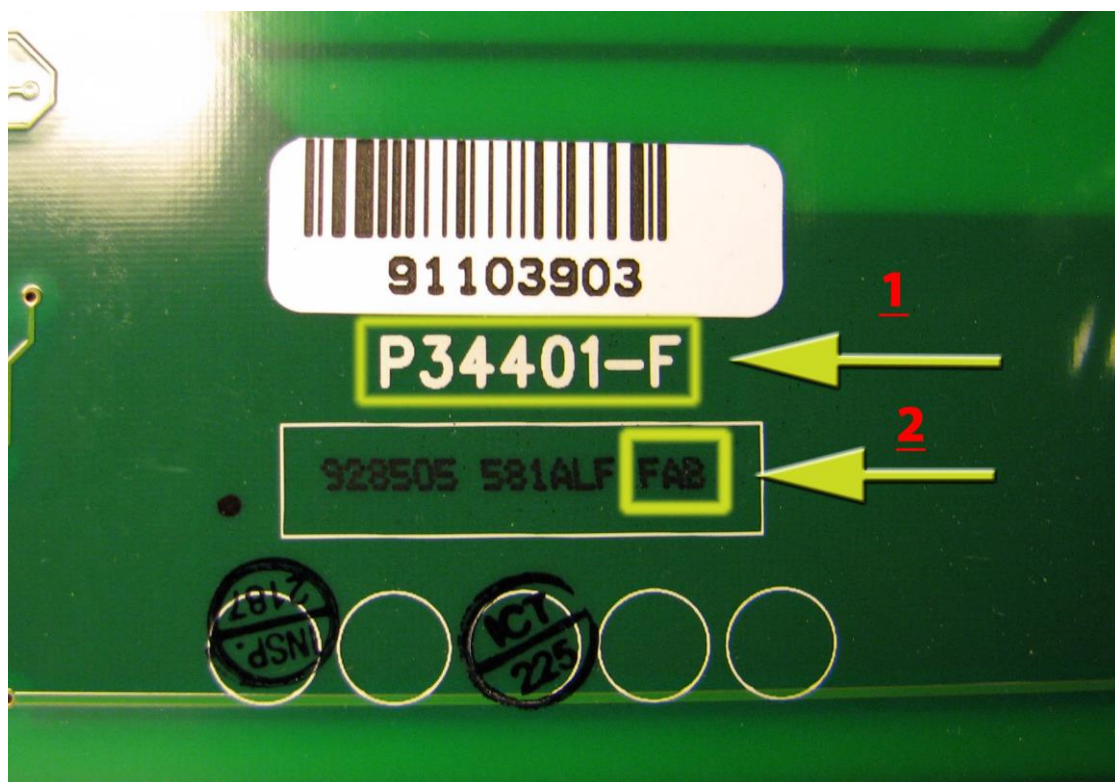
In the example in picture (2) F indicates the PCB revision number F and the third letter B is the boom version

This board is P34401 revision F and boom b

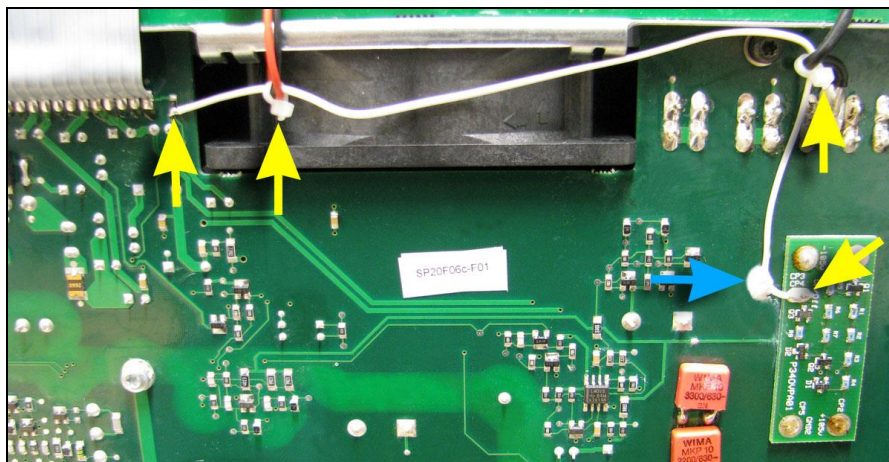
**SP20F-F01 Mount Ferrite and apply glue if it's not mounted on D3.**

| | Mount Ferrite on D3 according to picture. | | |

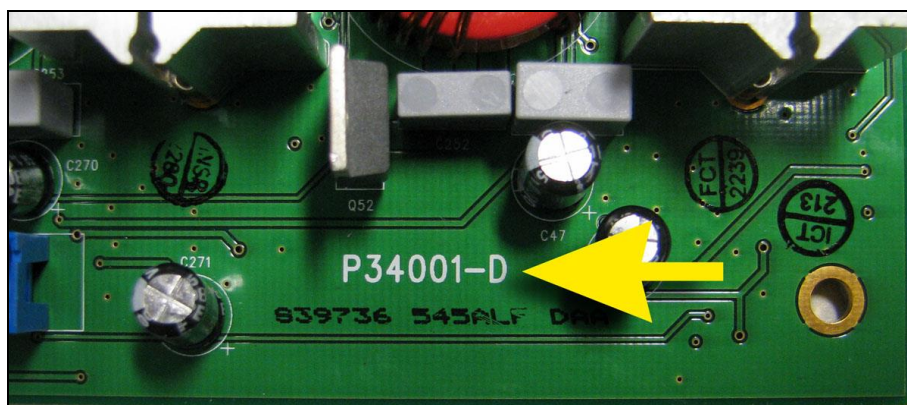
### PIC1

In the example in pic1, the “D” indicates the PCB revision number. Whenever you encounter a PCB revision number “D” or below, see if the capacitors are mounted like in Pic2 (see red arrows) then the board has been updated to the latest revision so you can continue repairing.

If they are not mounted you need to replace the A104D-P34001. See the spare parts list for the correct spare part.

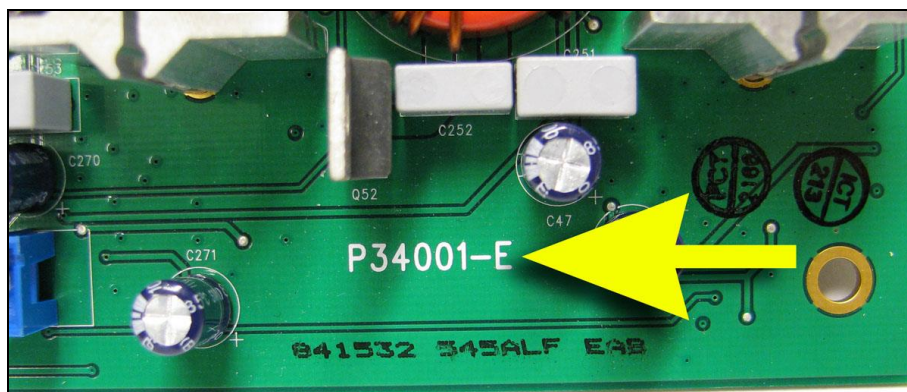
Instruction concerning A104d- P34001Revision "E"

**Remove capacitors C200-201, C204-205, C215-216 & C219-220.**

Replace it with 0,1u 250V
