Service Note		
Product	Description:	Service note no.
SCF pedal	Overload diode always slightly on	713 10 1773

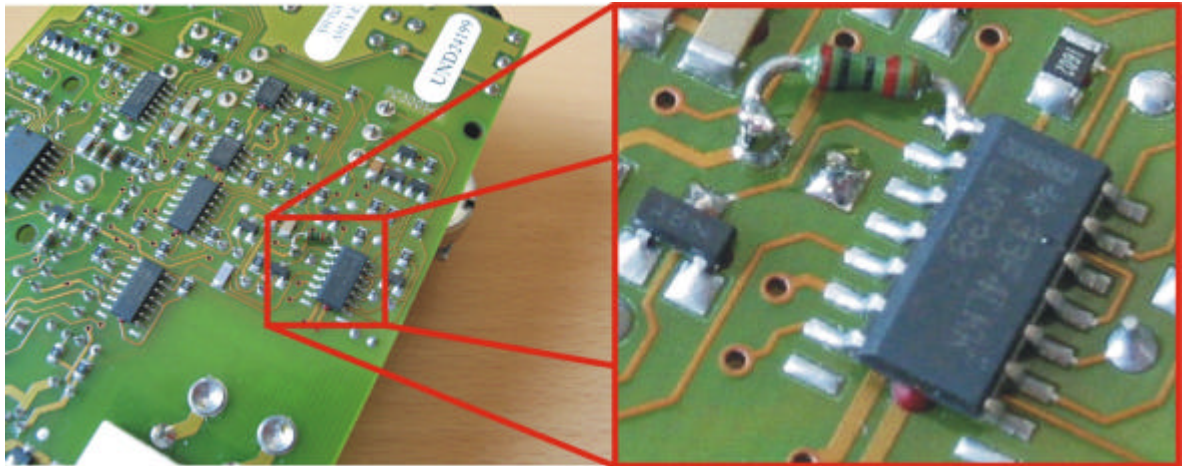
SCF, Overload diode always slightly on

The overload LED was slightly on all the time.
To stop this, a 20kOhm resistor is mounted between IC6 pin1 and LD2 anode.

Implemented from S/N: 38000 (110V versions) / 105926 (230V versions).
