| Service Note | | |
| <b>SDI card</b> | <b>Resistor added</b> | <b>SNo-T0113</b> |

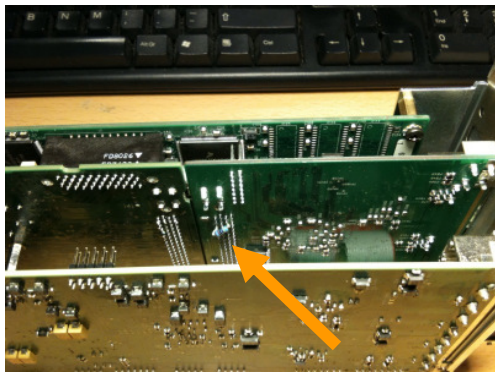
Some of the SDI cards (HW version 203 – identified by visible Firewire connector on the backplate) have been shipped without the resistor by a mistake. See the picture. If the resistor is missing there is a risk that the DB4/8 frame will see the SDI card as an AES card.

All stock should be checked and the resistor should be mounted if missing. The resistor is a 4700 ohm ¼ Watt.

The resistor shall be mounted if missing. The resistor is a 4700 ohm ¼ Watt.

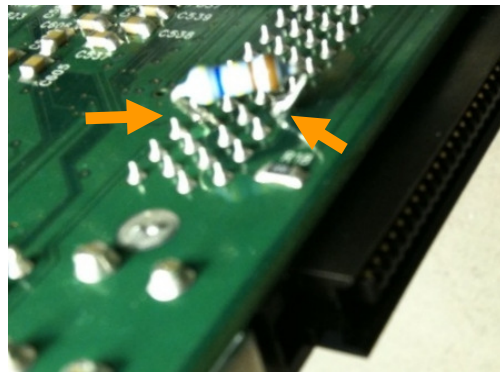
Mounted like this
