Service Note		
Products	Description:	Service note no.
VoiceSolo FX150	Improvement for audio quality	SNo-T208

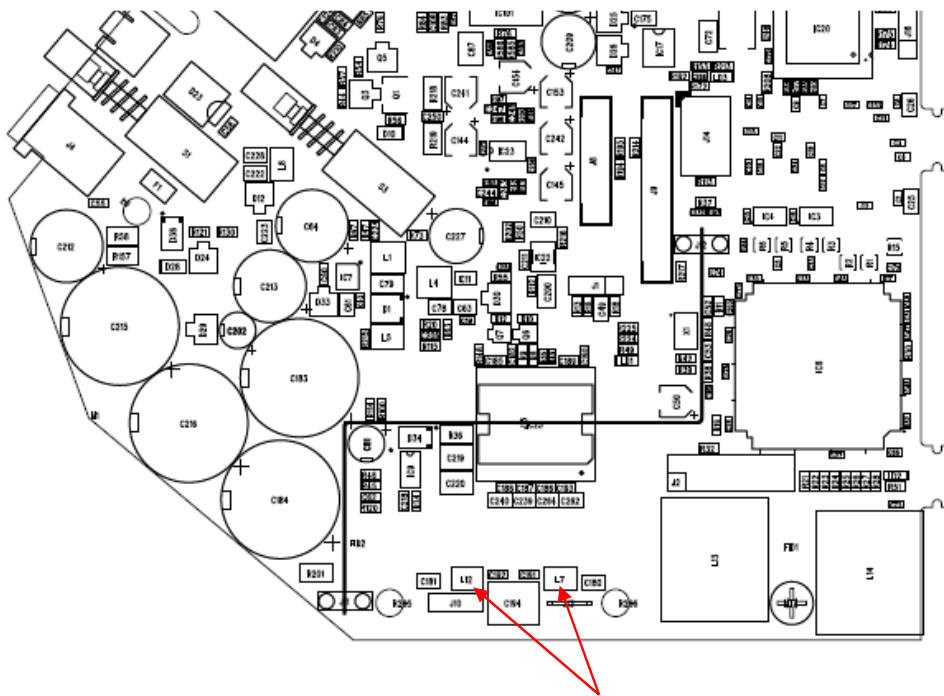
Some customers have experienced issues with buzzing or low frequency speaker noise

Placement of L7 and L12

If a product comes in for service with symptoms like above mentioned the problem can most likely be solved by exchanging L7 and L12 in the power amplifier section with ultra low ohmic resistors.
