Technical Service Bulletin No. 36

Created by: Lab.gruppen AB Service Department

Reference no: Missing support post

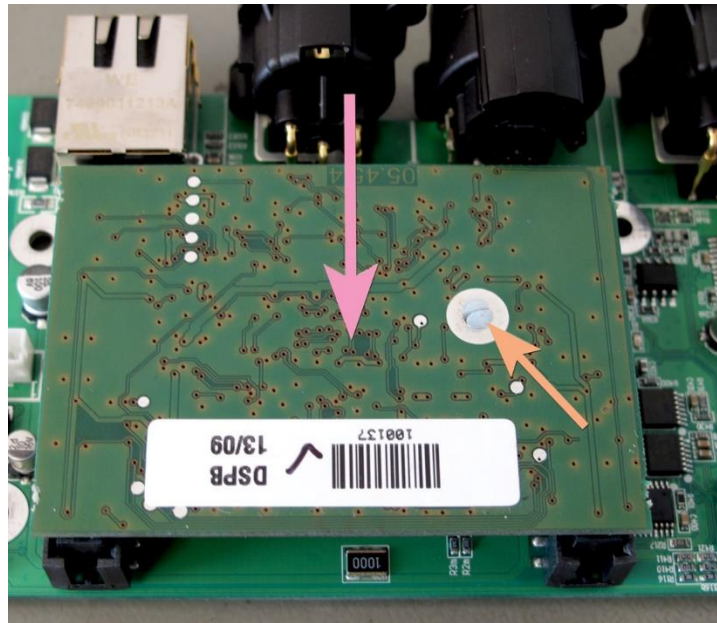
1	Do a visual check and see if the support post is mounted (see orange arrow)	
---	---	--

Make a visual check to see if the support has been mounted.

Mount the support if it is missing

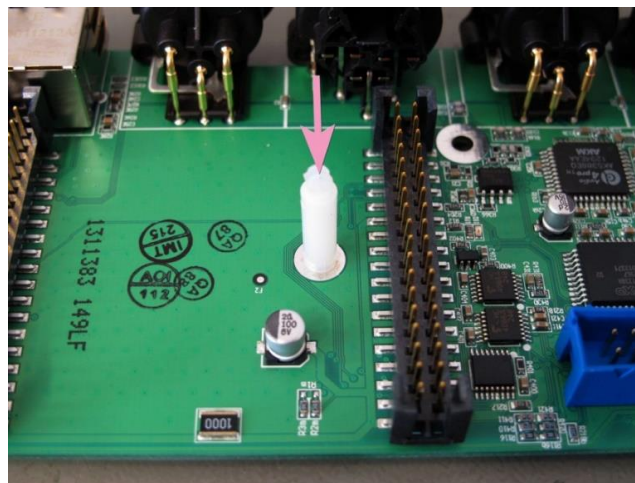
3	Dismount the DSP board and then mount the support post (see pink arrow)	
---	---	--

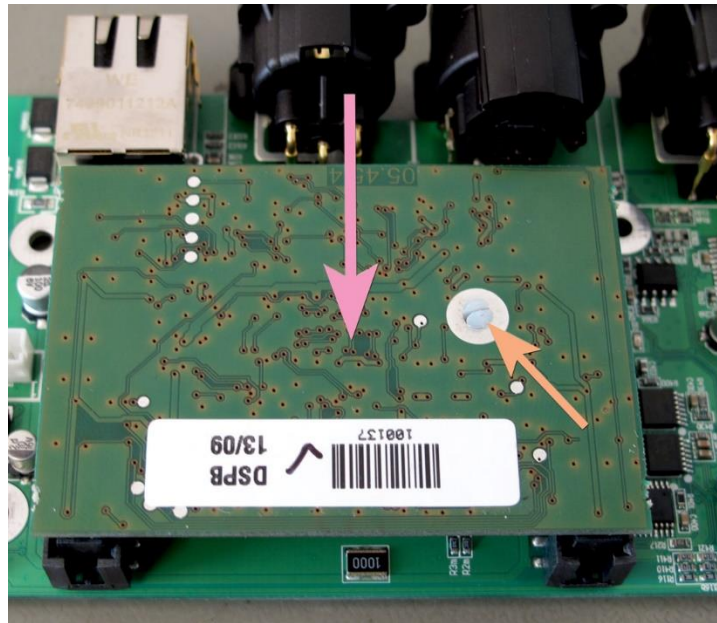
4	Mount the DSP-board back on to the ADIC board	
---	---	--
